Effects accompanying the passage of various discharges through Edfina Barrages

Emam A. Osman, Ahmed. M. Elfarouk, Mohamed. S. Abdelmoaty and Yaser M. Ali

Channel Maintenance Research Institute, National Water Research Center, Delta Barrage, P.O.Box 13621, Egypt.

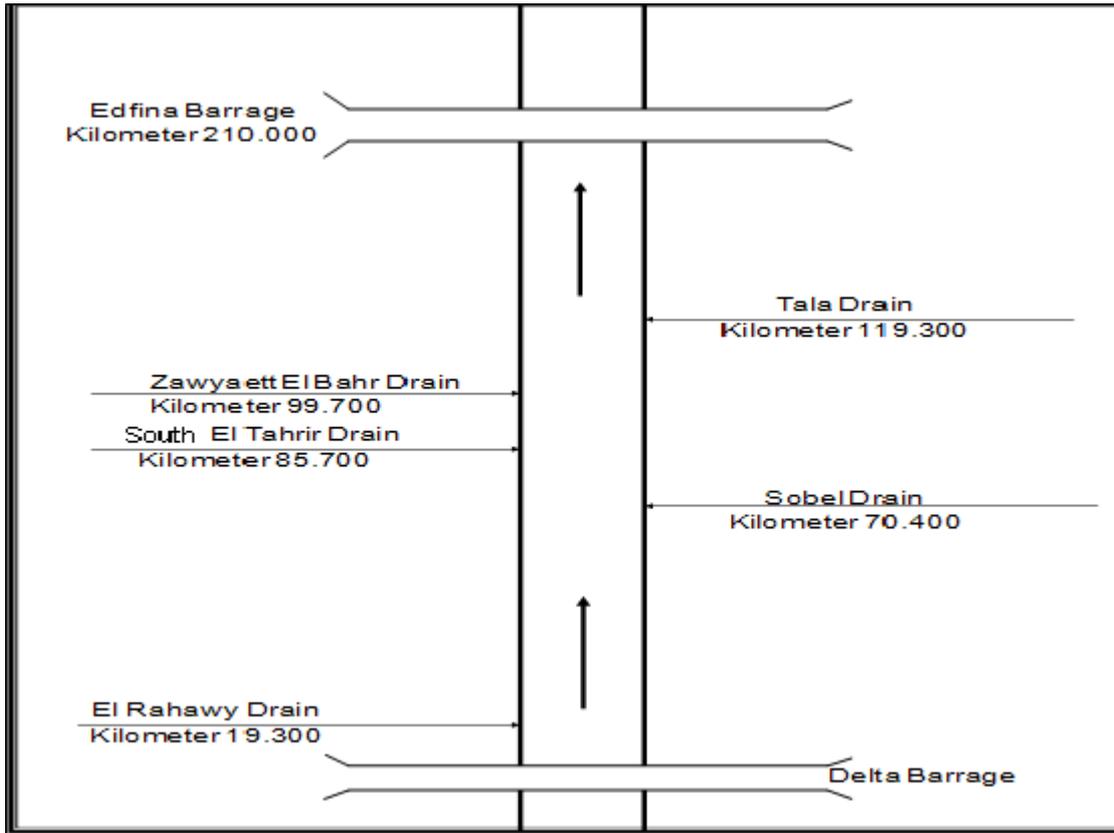
Fig. (1). Sketch of study area and drains outfalls in Rosetta Branch

This study was carried out nearby Edfina Barrages, 210 Kilometer distance downstream Delta Barrages as described in Figure(1), at the reach between 2 kilometers upstream and 40 kilometer downstream Edfina Barrages. Edfina Barrages have water lock of 12 meter width, 46 openings of 8 meters width, and car road of 12 meter width. The Management of these Barrages is supervised by Edfina Irrigation District, which follows general directorate of Delta Barrage.

- Sewage network of Rashed City flows into Rosetta Branch U.S. Edfina Barrages as illustrated in Photo (1).
- There are drains, Tala, (Fig. 1) flow into Rosetta Branch and carry direct and indirect pollutants [4], [5]. such as Elrahawy. Ganob Eltahreer, Zawiett Elbahr, Sabal,

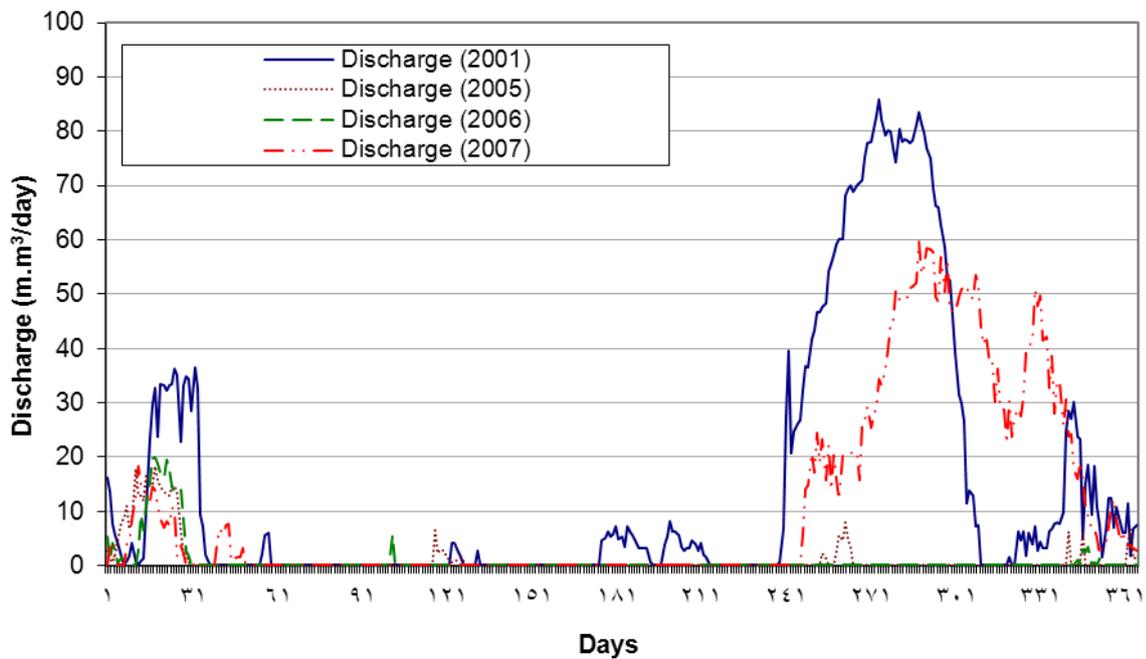
Fig. (2). Discharges through Edfina Barrages

- In April 2008, the water flowed through three openings only and had greening slash foam as illustrated in Photo (4).
- Figure (2) presents the fluctuation of discharge through Edfina Barrages during 2001, 2005, 2006, and 2007. Also indicated that the maximum discharge passing through Edfina Barrages was 85.95m.m³/day at October, 2007, and the minimum passing discharge was 0.200m.m³/day which is constant for many months through the year.

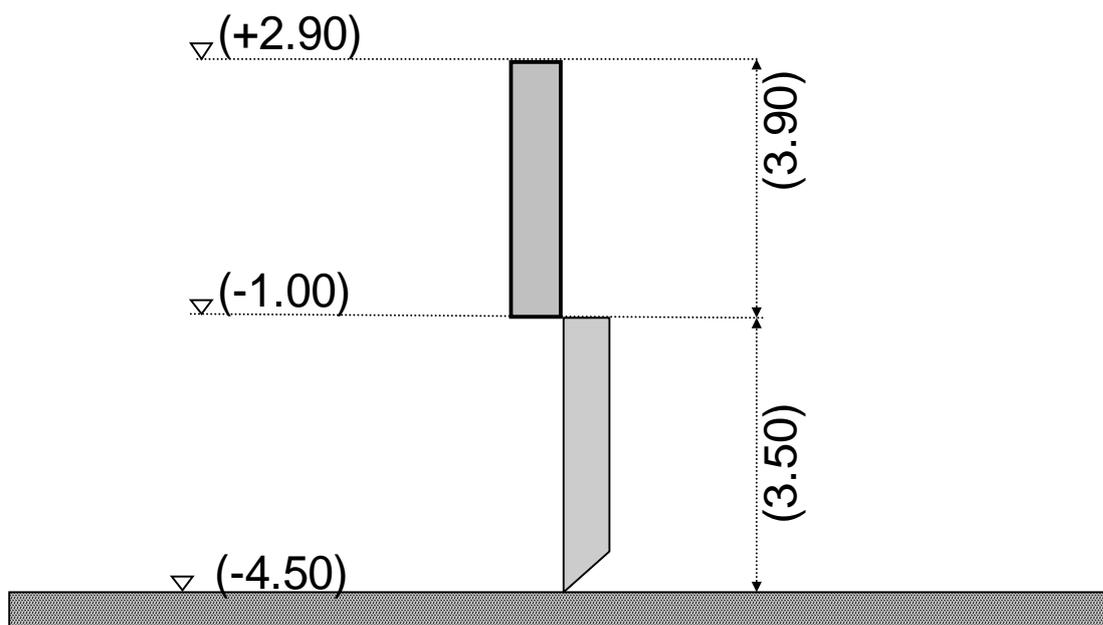
Fig. (3). Levels of Sluice Gate

- Every opening of Edfina Barrages has two vertical sluice gates, water was distributed by fixed the lower gate to the apron bed, and moving the upper gate as illustrated in Figure (3).

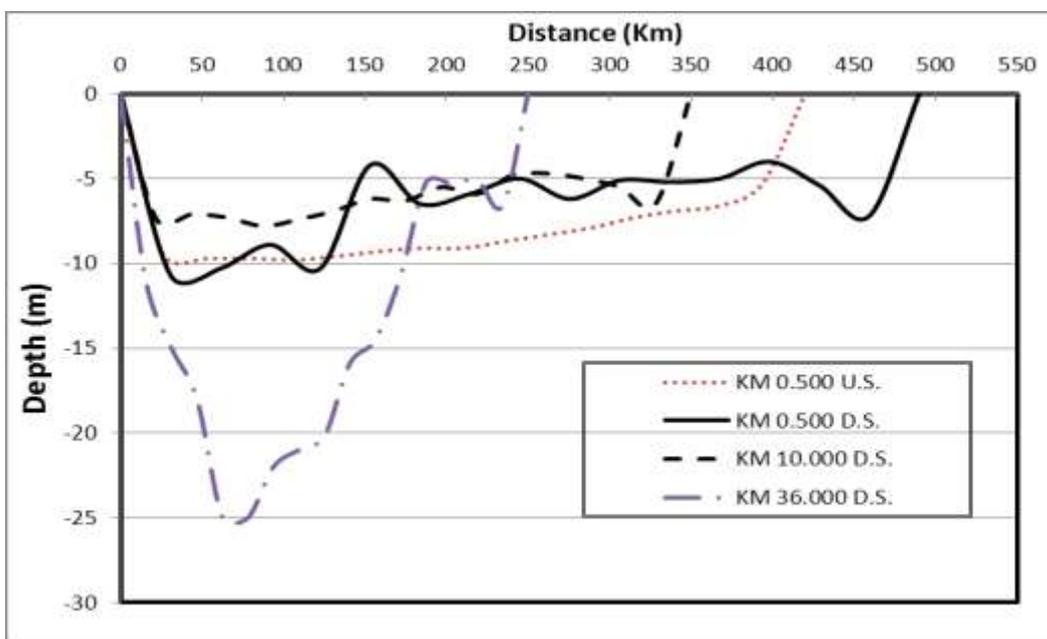
Fig. (4). Cross Sections U.S. & D.S. Edfina Barrages

Identifying depths of water, depositions, and scouring in the studied reach were carried out at the same locations of measured velocities and surveyed by using Echo Sounder instrument. The results showed that the water depths ranged between 4.00 m to 10.00 m, and the left side of watercourse was more scour directly downstream Edfina Barrages than the right side as illustrated in Figure (4) as a result of passing water through the water lock and a few openings at the left side of the barrages.

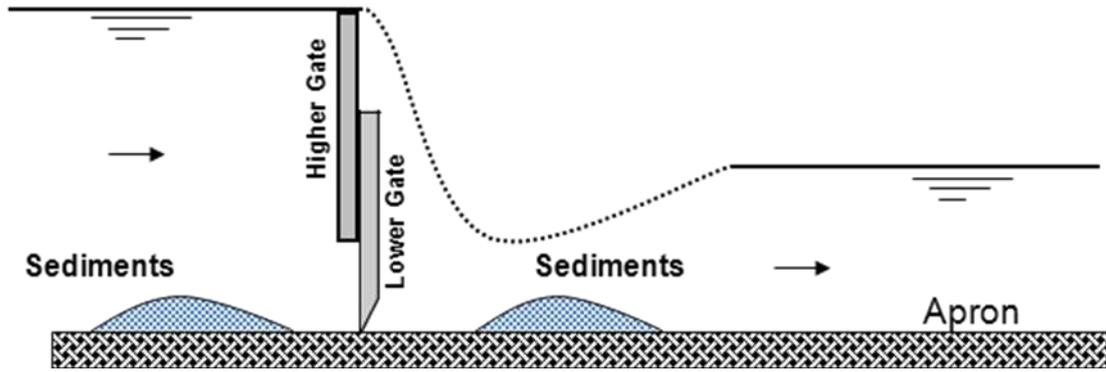
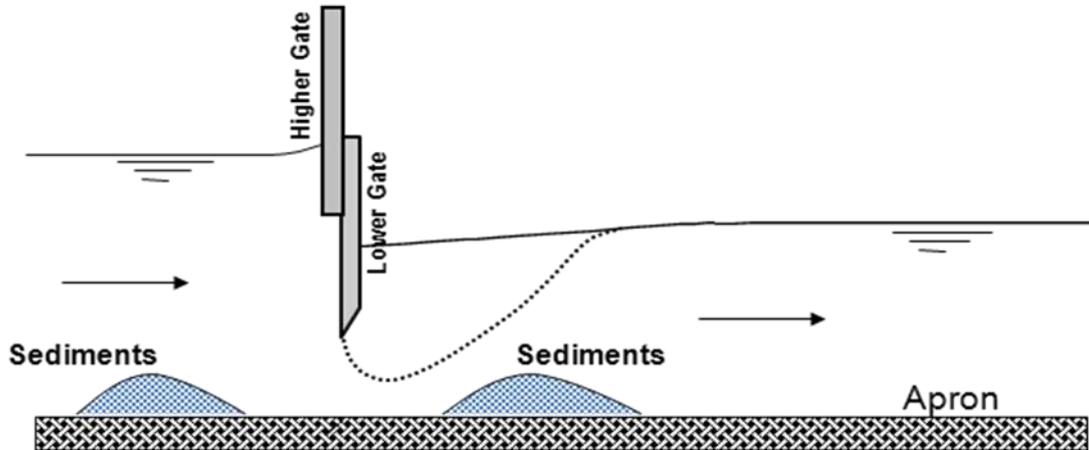
Fig. (5-a). Usual Gate Operation

- Operating the lower gate of Edfina Barrages and installing the upper one to pass the water and the reserved sediments on the apron continually as shown in Figures (5-a,b).

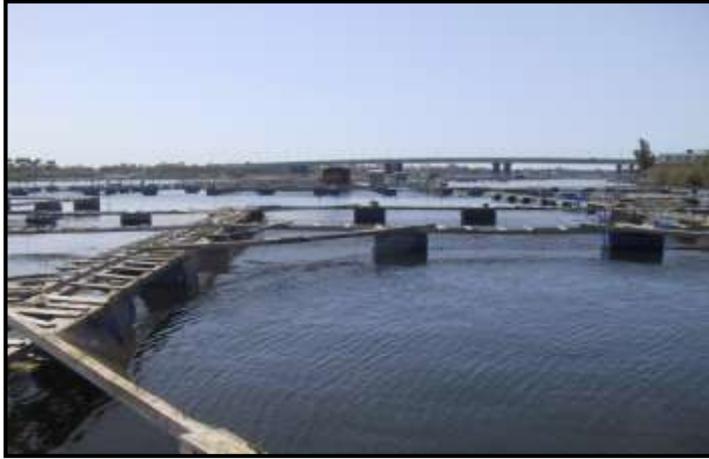
Photo (2). Irregularly Cages Downstream Edfina Barrages

- Almost 3500 cages were accumulated in random arrangement at watercourse downstream Edfina Barrages (Photo 2). These cages contain types of fish as (Family: Cichlidae), Monosex, *Oreochromis niloticus*, and *Oreochromis aureus*.

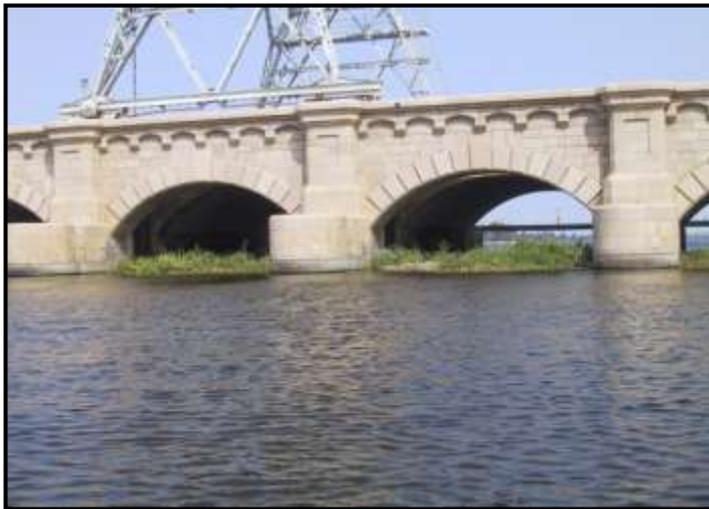
Photo (3). Accumulated Weeds Upstream Edfina Barrages

- Remnants of fish feed were accumulated on the bed of watercourse below cages.
- There was floating, cut weeds, and dead animals accumulated directly upstream and downstream the openings of Edfina Barrages as illustrated in Photo (3).

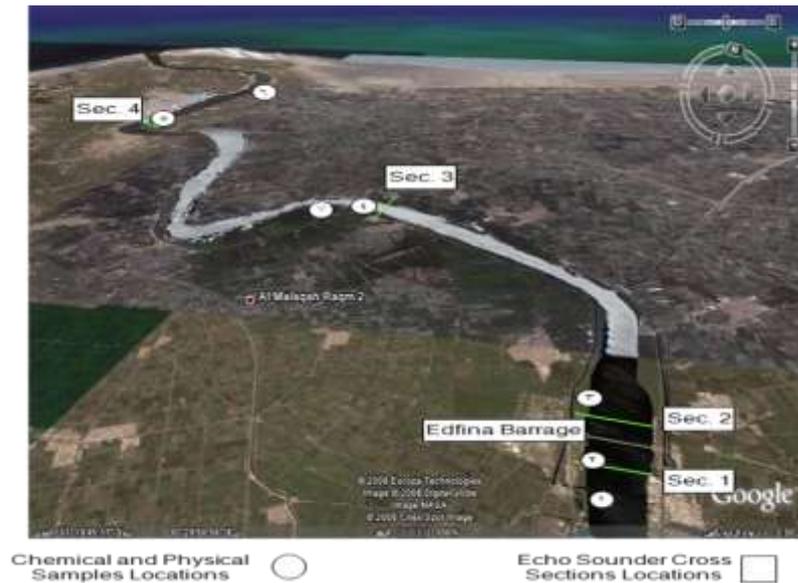
Photo (5). Locations of Water and Soil Samples

Water velocities were measured by using Electro Magnetic Current Meter on four cross sections located at 0.500 Kilometers upstream Edfina Barrages, and 0.500, 10.000, and 36.000 kilometers downstream Edfina Barrages as shown in Photo (5). It was noticed that the average actual water velocity varied from 0.06 m/sec to 0.08 m/sec for the cross sections downstream Edfina Barrages. While the average actual water velocity was 0.05 m/sec at the cross section located at 0.500 kilometer upstream Edfina Barrages.

During October 2008, samples of water and soil were collected from six locations at the studied reach, locations 1, 2 at kilometers 1.000, 0.500 upstream Edfina Barrages, and locations 3,4,5,6 at kilometers 0.500, 10.000, 36.000, and 40.000 downstream Edfina Barrages as shown in Photo (5).
